Acoustic Emission analysis of Diamond Turning Process of CNT Composite

Abstract In this paper face-turning using monocrystalline diamond tools of an epoxy nanocomposite containing multiwalled carbon nanotubes is investigated and compared with its base polymer (RTM6) and an aluminum alloy. Acoustic emission signals, machined surface integrity and chip morphology are the factors used to compare the machinability of the three materials. The acoustic emission results are compared to the response of an Al alloy cut under similar machining conditions.

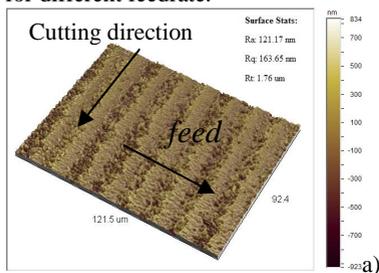
Figure 1. Acoustic emission RMS value for different feedrate.

In Figure 1 the AE RMS value for the CNT composite is very close to the values for the Al-alloy; for the lower value of feed rate (i.e, 5 and 10 µm/rev), the AE value is even lower for the composite, while for $f = 20$ µm/rev the value becomes higher than for the Al Alloy. Analyzing the AE RMS one can observe that values for the epoxy resin RTM-6 is higher than the other materials for almost all feed rates (5-

In summary, in this paper acoustic emission technique was used to monitor micromachining of epoxy resin CNT composite. The RMS signal amplitude of the acoustic emission response increased with the increase in feed rate. The increase in feedrate seems to have a direct relation to the brittle response of the epoxy resin during machining. RMS signal amplitude is increased when the brittle mode is achieved during machining of the composite and stable when monitoring the aluminum alloy. Chips were observed by means of SEM and it is not clear if shear bands or lamellar structure were the mechanism responsible for chip formation from the base epoxy. For the composite sample some “traces” of very small (~300 nm) shear bands were observed on the free surface of the chips. No sign of cutting edge wear was observed.

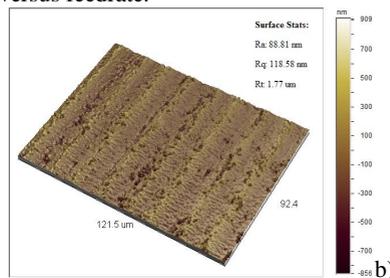
Figure 2. Surface roughness values versus feedrate.

20 $\mu\text{m}/\text{rev}$). In the case of the epoxy resin RTM6 brittle damage (microcracks) was detected for all cutting conditions which also were reflected in the surface roughness. Figure 2 shows the roughness Ra values for the three materials tested. The roughness of the epoxy resin was always higher than the other materials. Figure 3 show 3-D images of the epoxy resin sample (RTM-6) and the composite (0.7%CNT). Fig. 3 (a) shows that the epoxy resin presents more sign of brittle damage than the composite (Fig. 3(b)). Comparing these results with the RMS values, the higher the levels of AE signal may be attributed to the larger the number and concentration of cracks. One can conclude that frequencies are distributed in a manner that high frequencies and high level of signal are related with the presence of massive number of cracks (RTM-6), while lower frequencies and lower signal levels indicate ductile material removal (Al-alloy). The results showed that all cutting conditions yielded ductile material removal for the aluminum alloy.

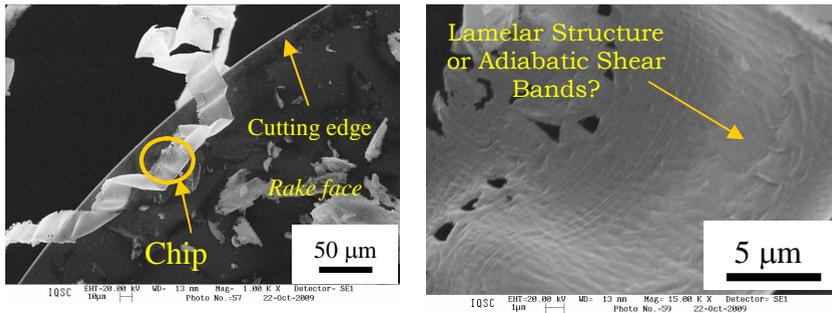
Figure 4. SEM image of the cutting edge used in the machining tests.

Figure 4 (a) show some chips left on the cutting edge of the diamond tool used. Fig. 4 (b) shows a detail view of the chip shown in Fig. 4(a). The “microstructure” shown on the free surface of the chip is not clear if there is a lamellar structure or adiabatic

shear bands which is characteristic of materials having low thermal conductivity [4]. In high CNT concentration (10%) in Polycarbonate matrix the shear bands do not appear [5]. Just reminding that in our composite the concentration was 0.7% wt.
