## Additive manufacturing for the repair of gas turbine blades with internal cooling channels: A sealing approach to prevent powder penetration

Laser Powder Bed Fusion, Gas Turbine Blade Repair, Sealing Technique

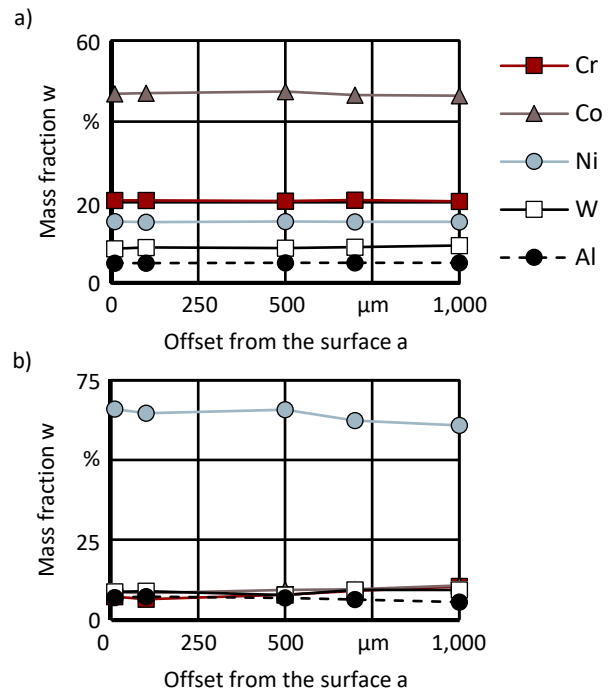
**Figure 2.** Elemental mass fractions determined by EDS as a function of distance from the surface: (a) additively manufactured region, (b) cast region.

To further investigate possible chemical alterations induced by the ammonia solution, energy-dispersive X-ray spectroscopy (EDS) was performed on selected cross-sections. Elemental composition was measured at distances of  $a_1 = 10 \mu\text{m}$ ,  $a_2 = 100 \mu\text{m}$ ,  $a_3 = 500 \mu\text{m}$ ,  $a_4 = 700 \mu\text{m}$  and  $a_5 = 1,000 \mu\text{m}$  from the external surface, in both the cast and AM regions. The results, presented in [Figure 2](#), showed fluctuations in the measured values of  $\Delta w = 8\%$ . These variations are attributed to methodological uncertainties, particularly considering the penetration depth of the technique, which can result in signal contributions from carbides.
