## Milling-induced damage characteristics of 70wt% Si/Al alloy

High-mass fraction silicon-aluminium (Si/Al) alloy (mass fraction of Si is larger than 30wt%), renowned for its excellent thermal conductivity and soldering performance, finds extensive application in the encapsulation shells of electronic components. However, the main challenges in machining Si/Al alloys stem from their high hardness, brittleness, and heterogeneity, resulting in poor surface quality and significant tool wear. In this work, milling-induced damages of 70wt% Si/Al were analyzed. K9 glass was selected as a reference group to reveal the damage characteristics caused by the heterogeneous of Si/Al alloy. In addition, the cutting force and machined surface roughness were investigated. The results show that brittleness and plasticity coexist in Si/Al alloy. The brittleness of silicon particles leads to the formation of pits and cracks on the machined surface, while the high ductility of aluminium contributes to the occurrence of burr defects. With the increase of feed rate, machined surface roughness of Si/Al alloy initially decreases and then increases. This study provides a technical guidance for the efficie

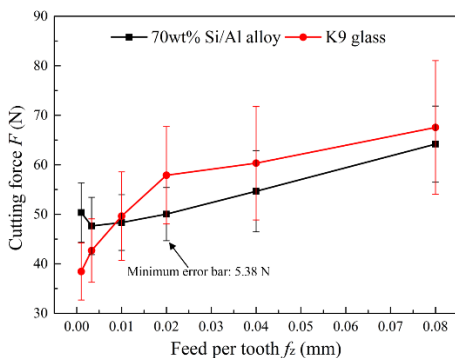
**Figure 3.** Variations of cutting force with feed rates

During the cutting of K9 glass and 70wt% Si/Al alloy, the average cutting force exhibited different variations. As shown in Fig. 3, the changes in cutting forces with varying feed rates are depicted. Due to the large amount of Si particles in the workpiece, the cutting-edge is subject to high-intensity impacts during milling, resulting in significant fluctuations of cutting force. In milling of 70wt% Si/Al alloy, the cutting force initially decreased and then increased. Specifically, within the feed rate range of 0.001 – 0.003 mm/z, the cutting force decreased. This phenomenon was attributed to the feed rate being smaller than the cutting-edge radius, causing the aluminium in the Si/Al alloy to undergo ploughing with the cutting-edge. With an increase in feed rate, the ploughing effect diminished, leading to a gradual reduction in cutting force. The minimum cutting force of 47.6 N was reached at a feed per tooth of 0.003 mm. Beyond a feed per tooth of 0.003 mm, the cutting force increased with the feed rate. The ploughing effect became insignificant. Since there was no ductile material in K9 glass, no ploughing phenomenon occurred during its machining [4]. In addition, when milling K9 glass, abrupt fluctuations in cutting force occurred due to the brittle fracture of the material. In the case of Si/Al alloy, the minimum cutting force fluctuations appeared in the feed per tooth of 0.02 mm. Significant abrupt fluctuations in cutting force were observed when the feed per tooth exceeded 0.02 mm, as the high ductility of aluminium reduced the occurrence of brittle fracture in the material.
